Impacts of rainfall events Lockyer focal area: flood report II

This report documents impacts of the flood event in the focal area 10 January 2011. It is an addit to *Impacts of rainfall events Lockyer focal area: 6 January 2011* (flood report I) which documents flood damage 27 December 2010.

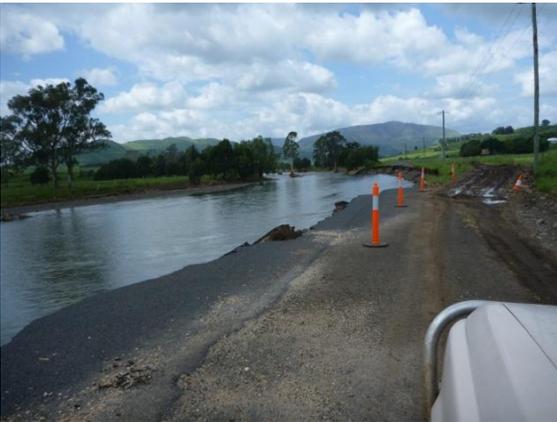
This rainfall event compounded damages which occurred following events December 2010. Most erosion occurred in the main channel, Fig 1 & 2. Banks collapsed along hundreds of metres with scour behind established trees and where vegetation was growing within the channel immediately upstream, Fig 1.

Figure 1: Blackfellow Creek facing south and remains of Mt Sylvia Rd. Instream vegetation immediately upstream diverted flow into bank causing scouring.

- battering back vertical banks and reestablishing bank vegetation,
- dedicated wide (10m+ each bank), thickly vegetated riparian zones along full reaches, and
- managing growth of vegetation in the main channel.

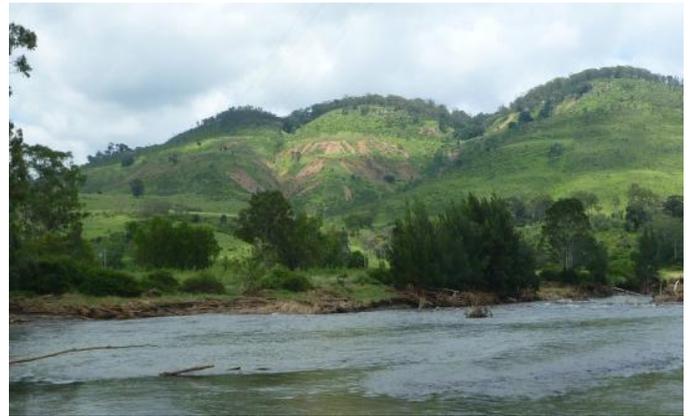
Figure 2: Extensive landslips occurred; common sites were of similar geology that had been historically cleared and frequently burnt; sites included where grasscover was well established.

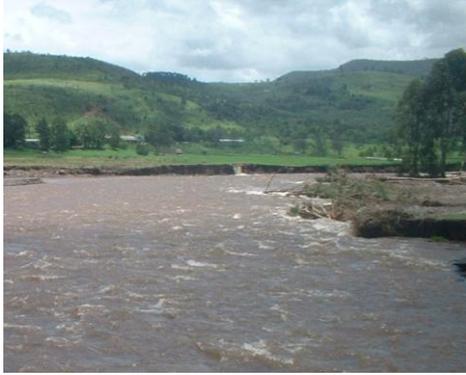
3. 18.01.11-
New creek meander into paddock, right; destroyed fencing, gates, troughs, pipe; fencing erected for groundcover management December

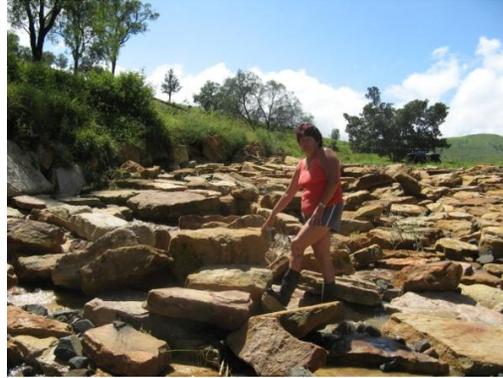
4a. 12.01.2011-
moderate rock movement will require excavator repair but chute essentially intact

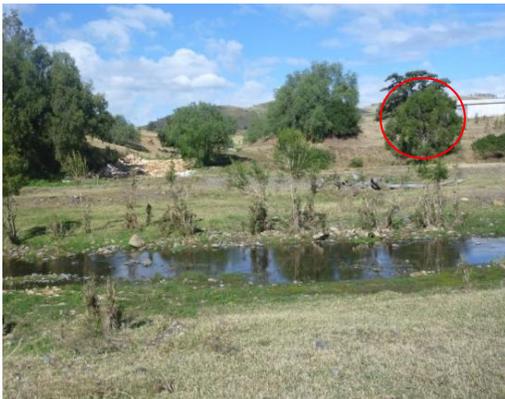
4b. 5.07.10-
main channel with rock chute in the background; reference point circled

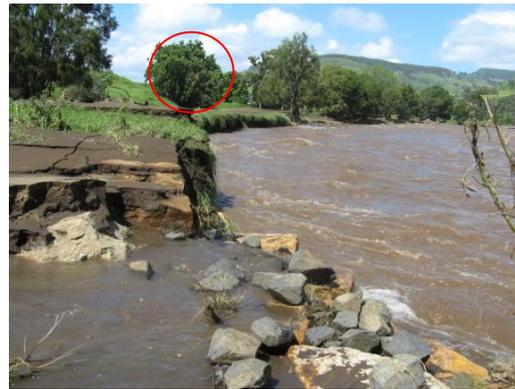
4c. 12.01.11-
Chute survived despite bank scouring; further erosion controlled

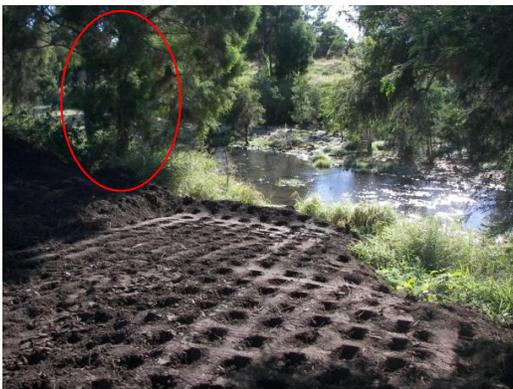
5a. 09.07.10-
during construction of lower of series of two rock chutes; reference point circled

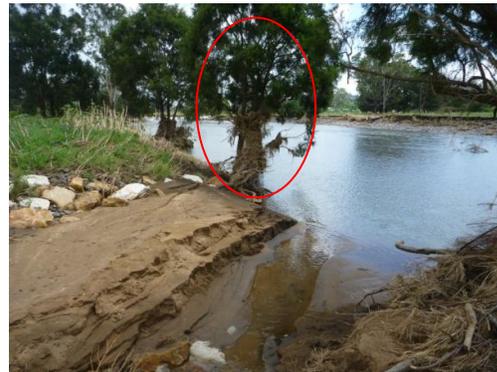
5b. 19.01.11-
lower rock chute buried in sediment; some rocks appear to be washed away, right, but essentially intact; note

increase in channel width and sheer scour opposite bank

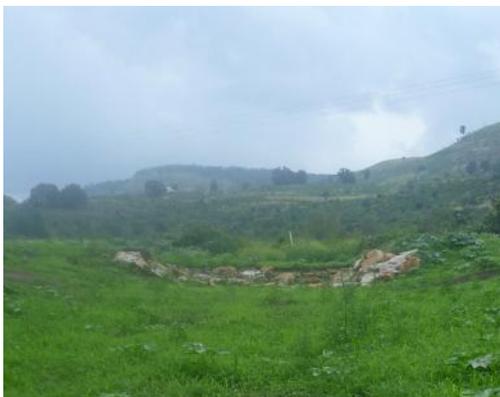
5c. 27.09.10-
upper chute beside road culvert soon after construction

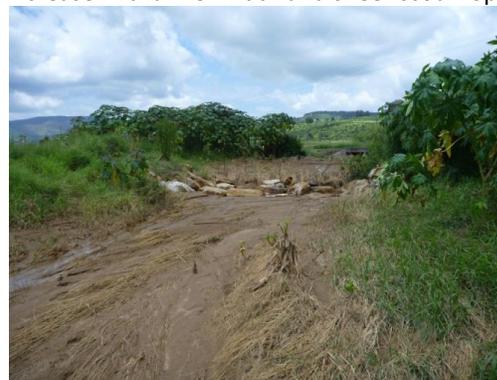
5d. 19.01.11-
chute appears intact and controlled erosion; associated drain controlled sediment into

waterway
