## Gully erosion repair

### **Case study: Gully erosion repair – Using a concrete mat**

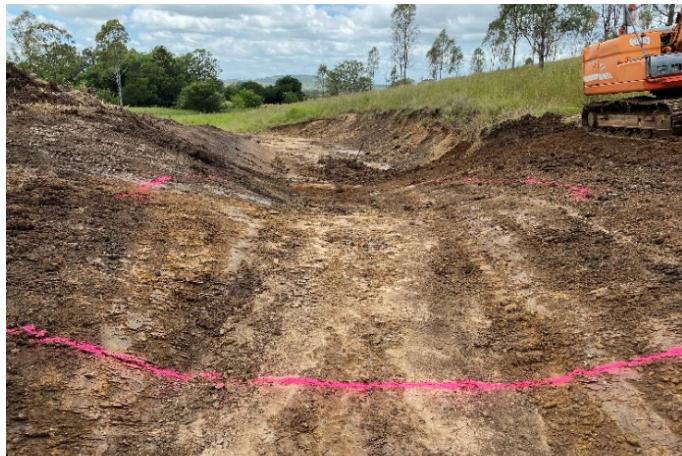
**Figure 6.** The gully sides were reprofiled to a 1:4 batter.

- **Batter gully sides** and remove the bank confining flows.
- **Reprofile the head cut and gully sides** using clay fill (from dam) and subsoil from reshaping the gully to create a 1:4 batter.

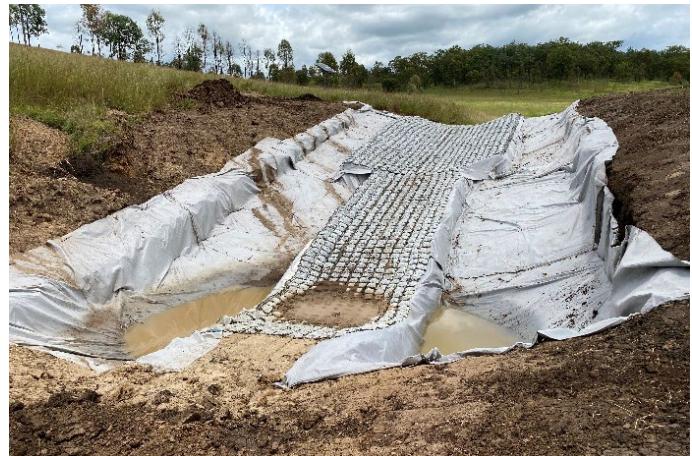
**Figure 7.** Geofabric overlayed across the entire chute and trenching and cement matting overlayed across the chute.

- **Overlay geofabric** across the entire chute and trenching.
- **Overlay cement mats** ensuring a minimum of two rows of cement blocks over the sides.

- The concrete matting came with its own geofabric lining which was too thin and broke down during a big rain event. This caused some erosion to occur underneath the matting. A44 bidum is the recommended minimum specification geofabric needed to protect the integrity of the chute and underlying soil.
- Don't step down from a two mat width to a one mat design. The excavation and boxing was more time consuming and expensive and did not deliver additional benefits.

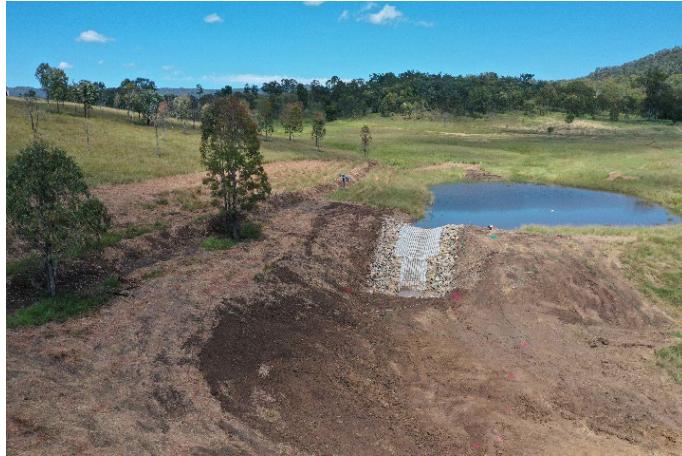
**Figure 8.** After construction the bare areas were seeded with a mix of productive perennial grasses and a cover crop.

- **Place rocks into trenches** surrounding the cement chute, ensuring that rock entry is flush with ground at the top of the chute.
- **Revegetate the batter** with grass cover across all exposed soil and plant vetiver hedges at the base of the chute.

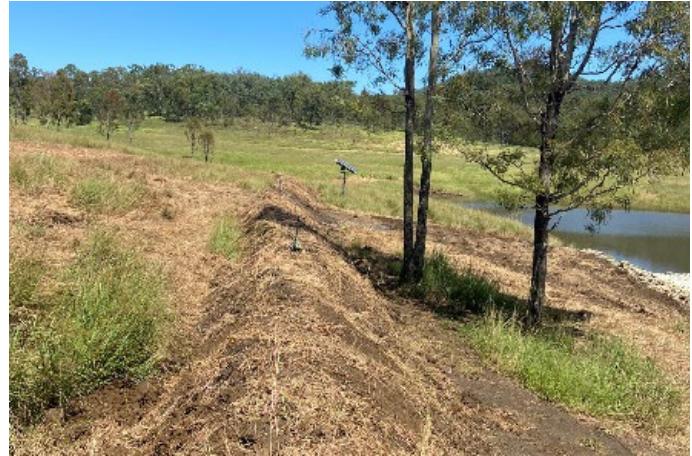
**Figure 9.** A contour bank was installed to divert runoff away from the restoration site.

- 1:10 fall ensuring topsoil is separated and put back on top.
- Compacted every 400 mm.
- Push up the hill from below contour.
- Ending the contour directing the water to a wide open, flat area above the dam.
- Seed the contour and the exposed soil below it to establish groundcover.
- Vetiver hedges installed where water is entering the gully above dam to slow velocity of runoff to prevent future erosion.
