Riparian Revegetation

Lessons from the Lockyer

Creek vegetation needed to slow erosion

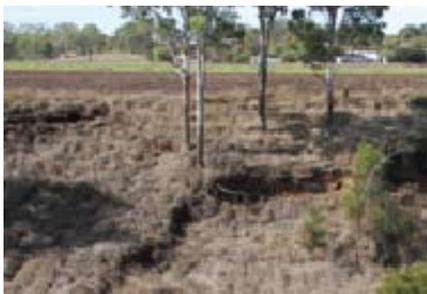
Trees holding their section of banks while bare areas slump – Lockyer Creek, near Gatton.

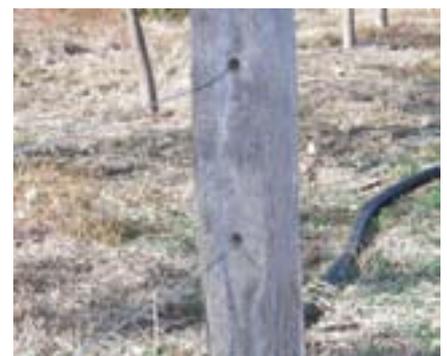
No catch – having 2 plain wires at the bottom of the fence reduces debris buildup.

A good feature of the Van Der Est's fencing is that the two bottom wires are plain wire which reduces the problem of debris catching on the wires so readily.
