Tunnelling

Muddying Lockyer Valley waterways

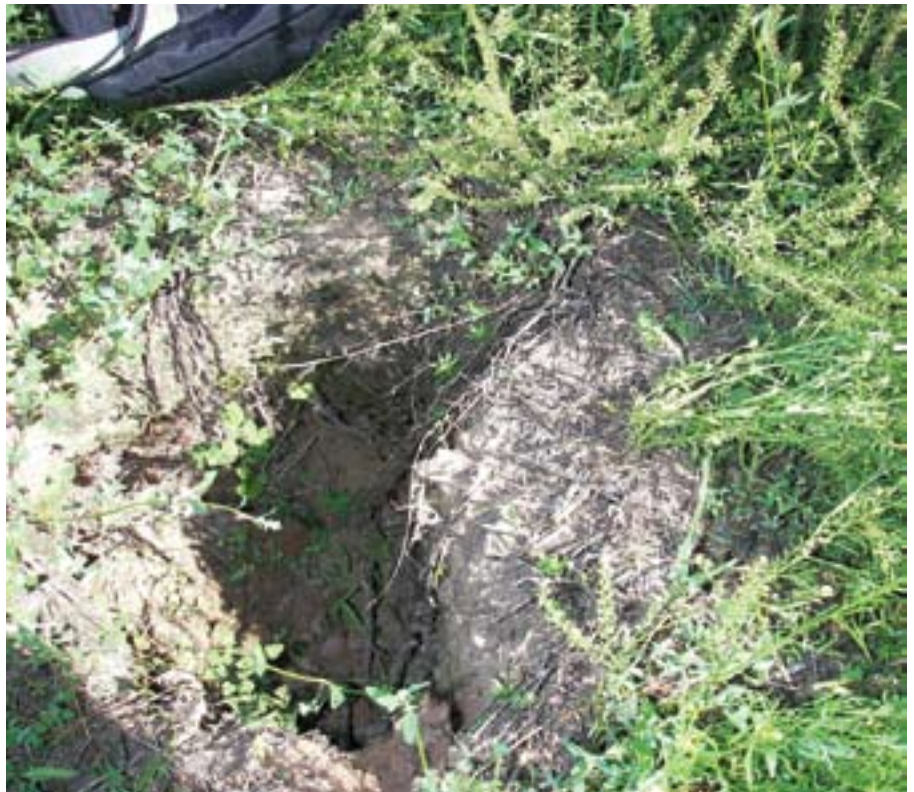
Lethal hole: Tunnelling is common in a number of areas of the Lockyer and nearby Marburg and Bremer catchments. Subsoil dissolves and is washed away, causing the surface to collapse, forming gullies. These sediments can stay in suspension reaching waterways.

Tunnel erosion is the erosion of the subsoil by water while the surface soil remains relatively intact. Later the surface can collapse causing gully erosion. It occurs in areas where the subsoil, or B-horizon, rests on an impermeable C-horizon and erodes more easily than the topsoil (A-horizon). Water passes through cracks or holes in the topsoil, caused by drought, tree stumps and adverse vegetation management (including overgrazing and fire).

A tunnel forms below the topsoil as rainwater disperses the subsoil. Very often one can see dispersed subsoil deposited further downhill. These 'tunnels' then collapse and form open gullies.

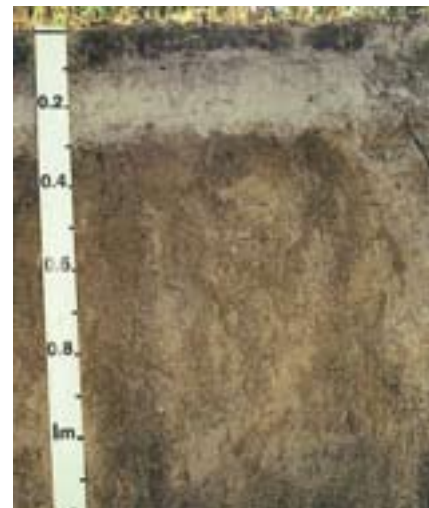
Soloths – vegetation on these soils is open woodland and open forest. Restricted plant growth due to poorly structured subsoil and the hard setting surface is also a contributing factor. The third layer (C-horizon) forms hard and saline subsoil. Generally, these soils are not suitable for agricultural land.

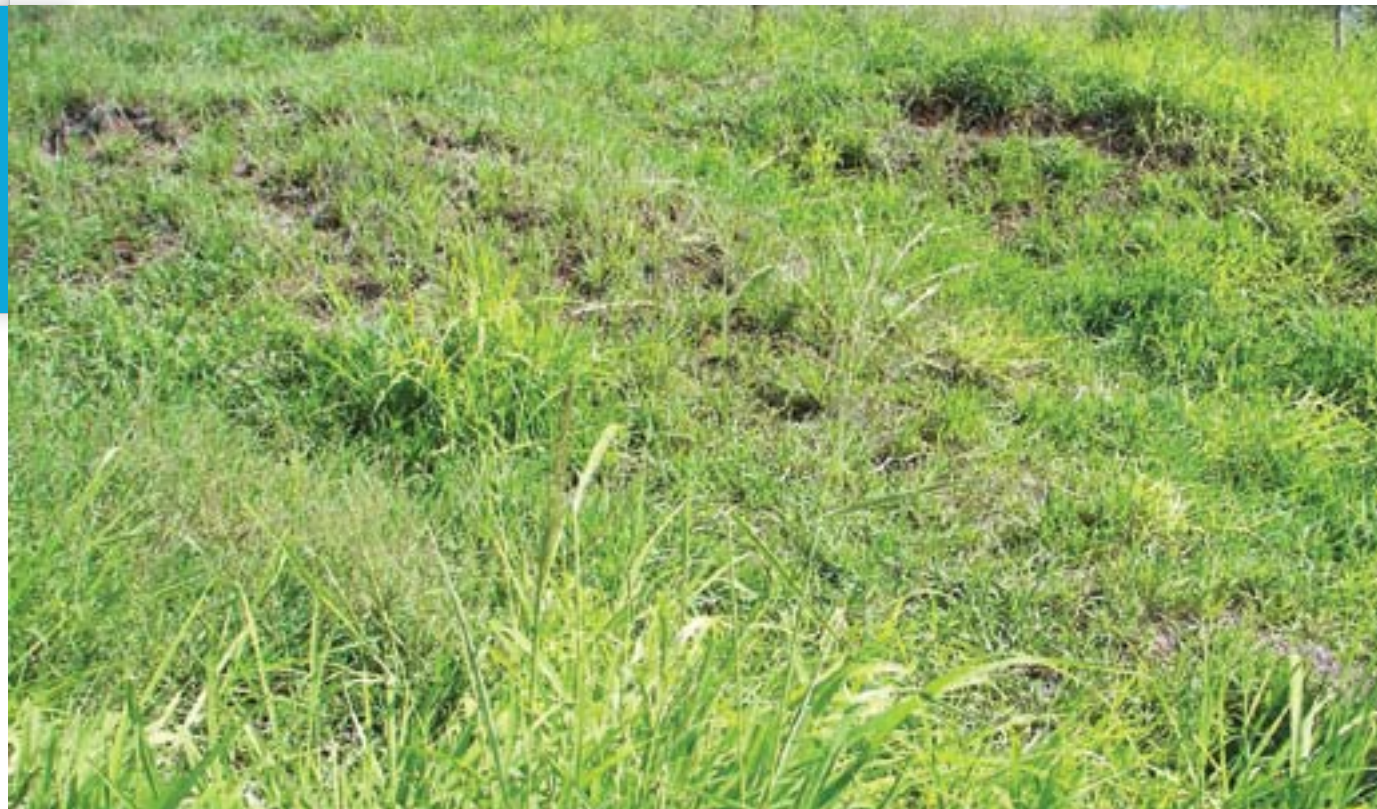
Repaired: An area of tunneling at Marburg has collapsed, and been stabilized with pastures.

On the northern end of Bob Hampson's Marburg property is the Kakandowie formation, which locals and others familiar with the landscape know for its susceptibility to tunnel erosion.

When Bob and Narelle Hampson finished eradicating lantana from their block, they found that they had a small area that continued to tunnel and slump.

After fencing the area and sowing pangola grass (*Digitaria erianthus subsp. Pentzii*) the area has established.

With a good cover of grass, the sides of the small gullies have smoothed and there has been little further erosion.

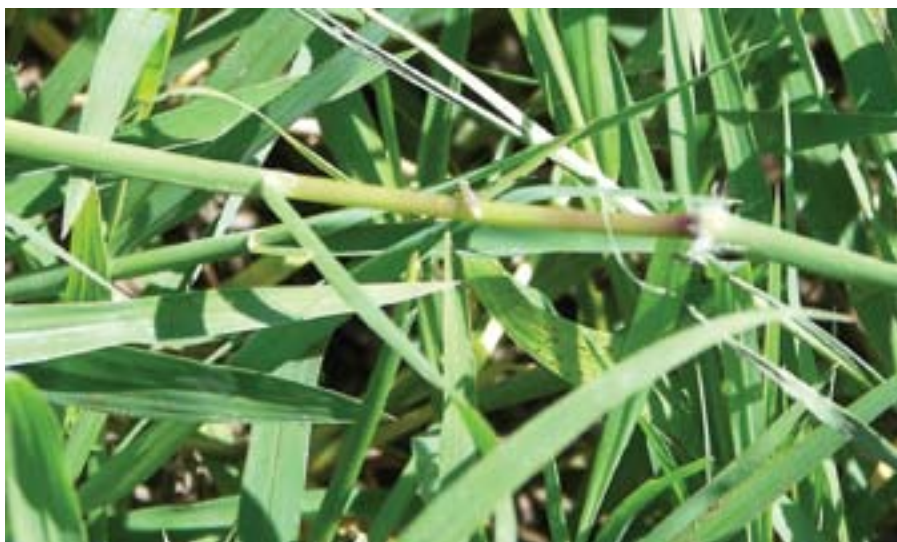
A pasture that has proven particularly useful in stabilising the area is Pangola (*Digitaria erianthus subsp. pentzii*).
