Lower Nerang River

Looking from numerous locations on the Lower Nerang River

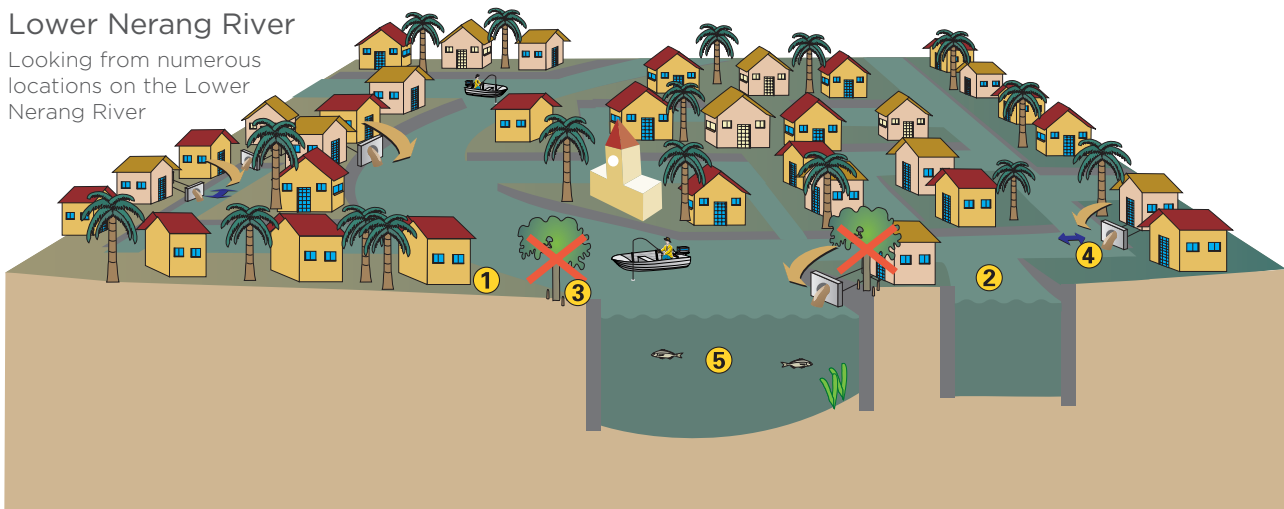
- 1** Catchment land-use of lower Nerang River dominantly urban
- 2** Creation of convoluted canal networks
- 3** Mangrove and saltmarsh in lower reaches replaced with hardened surfaces
- 4** Tidal flushing of storm-water entering canals is poor
- 5** Water frequently has a greenish hue although some seagrass remains
