# Gully erosion repair

## Case study: Gully erosion repair in the Ivory Creek

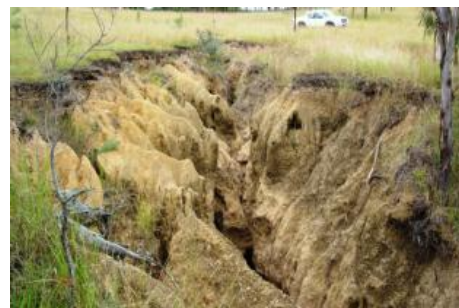
*Disturbance to the soil surface and exposure of the subsoil to both rainfall and overland flow can lead to gully erosion.*

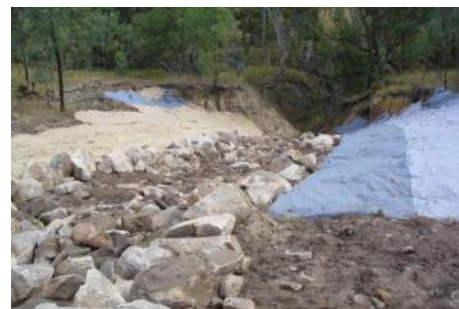
*A rock chute was designed for the catchment size with an erosion control blanket built into the design.*

After careful planning and design a rock chute to safely convey hillslope flows to the gully floor was installed. Restoration activities included:

- Ripping and compacting areas of subsidence and tunnel erosion at the head of the gully.
- Battering of the entire gully area to achieve a 1:1 slope (45 degrees).
- Calculating rock chute width, shape and slope to safely conduct water to the gully floor.
- Keying in and pegging down geofabric prior to rock placement.
- Installation of the rock chute down the centre of the batter.
- Establishing wing banks to direct runoff into the chute.
- Covering the remaining battered sides with erosion matting.
- Seeding the entire area with a cover crop combined with a suitable permanent perennial pasture mix.
- Fencing the site to exclude stock until a vigorous grass cover is established.
- Managing grazing access.
- Commencing the monitoring and maintenance program.

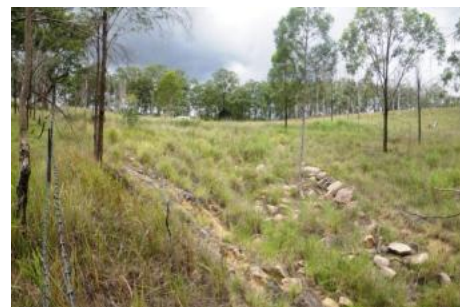
*Topsoil spread over the rock chute aided the establishment of grasses that help hold the structure in place. It survived the 2011 and 2013 flood events.*

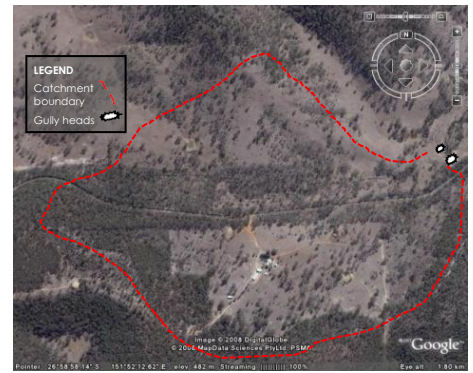
Your local Natural Resource Management group is often able to assist with aerial imagery and other information to assist in planning. Other tools such as Google Earth (above) and local knowledge can be used to help set design parameters.

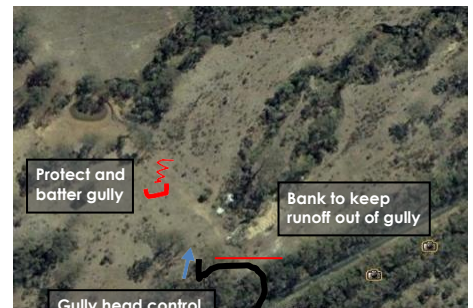
A dam to drown out the gully head was considered in combination with a diversion bank to prevent re-entry of water into the gully; making use of the stable grassed area between the gullies to conduct water downstream.

Design a gully head control dam to “drown out” the dual gully heads of the southern gully system and provide a temporary stilling pond to dissipate the energy associated with the overland flow entering the gully from the large, 100 hectare, catchment above. The dam spillway would discharge to the northwest where water could spread out over a grassed area before entering a relatively stable gully a short distance away. A bank adjacent to the gully would prevent overland flow re-entering the gully whilst it stabilises and vegetation establishes. The head of the nearby gully would be reshaped and stabilised using a rock chute.

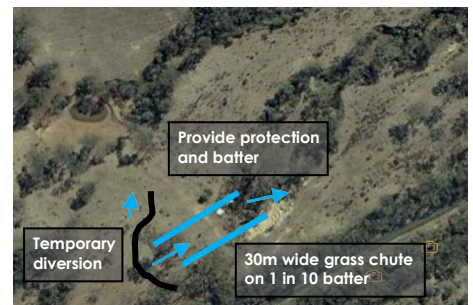
An alternative involved a grassed waterway after temporarily diverting flow away from the chute during grass establishment.

A second option to construct a grass chute constructed at a 1 in 10 batter to take the runoff from the current ground level to the bed level of the gully. This chute would need to be 30m wide to accommodate all runoff from the catchment and around 70m in length to achieve the desired slope. A temporary diversion bank across the head of the chute would be required to allow grass establishment. This diversion would need to be in place for a minimum of a full wet (summer) season to ensure the development of a dense and vigorous grass sward.

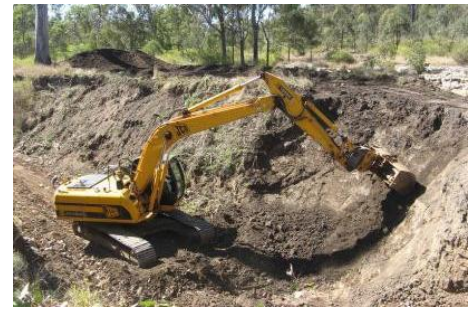
*Battering the banks of the gully reduces mass failure and provides a platform for vegetation to establish to protect the soil.*

- Battering the branches of the gully to a 1:1 slope.
- Shaping and compacting the dam wall across the advancing gully heads of the southern system.
- Reshaping the gully head of the northern system.
- Installing a rock chute to safely conduct water to the bed of the northern gully system.
- Fencing out stock.
- Establishing a dense groundcover of grasses.

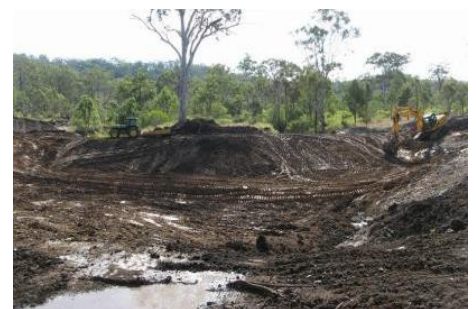
*Constructing the control dam across the dual gully heads included compacting the soil to improve the structural integrity of the dam.*
