## Case study: Gully erosion repair Using a rock chute

### Defining the problem

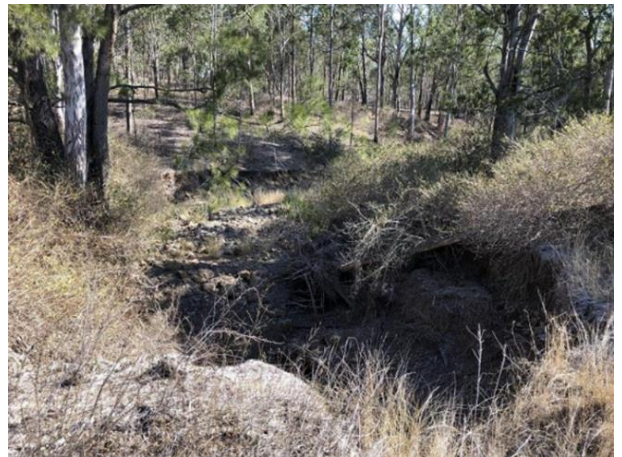
Gully head erosion had formed on a creek flowing through an alluvial blue gum flat. Over time this gully head had retreated back into the paddock creating an incision 8 m wide by 3 m deep.

Figure 1. The erosion site before restoration works.

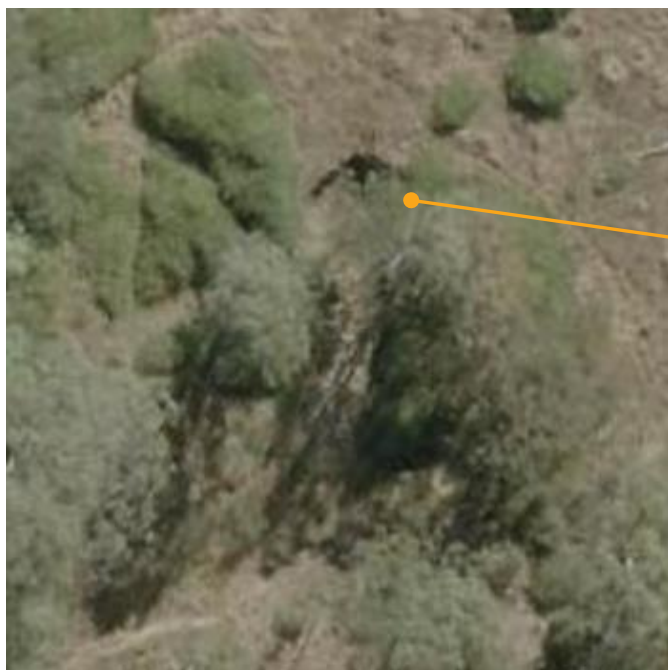
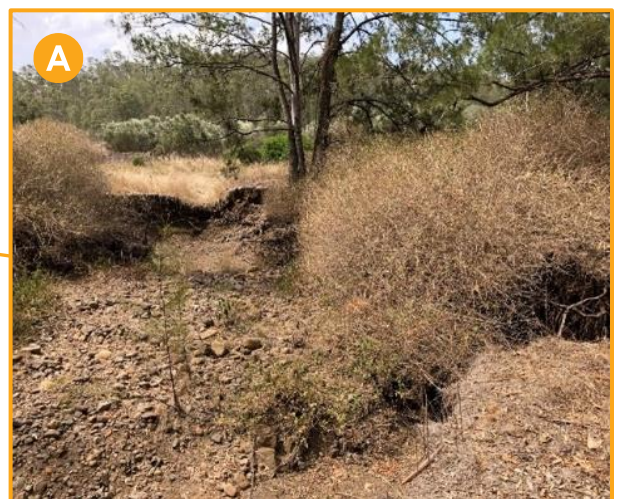
Figure 2. Aerial view of the erosion site before the erosion control work began. Inset A shows the erosion site looking upstream.

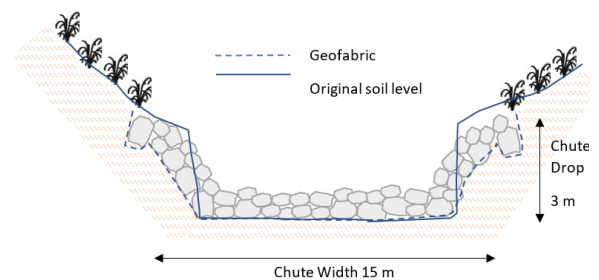
Figure 4. Cross-section of the rock chute design.

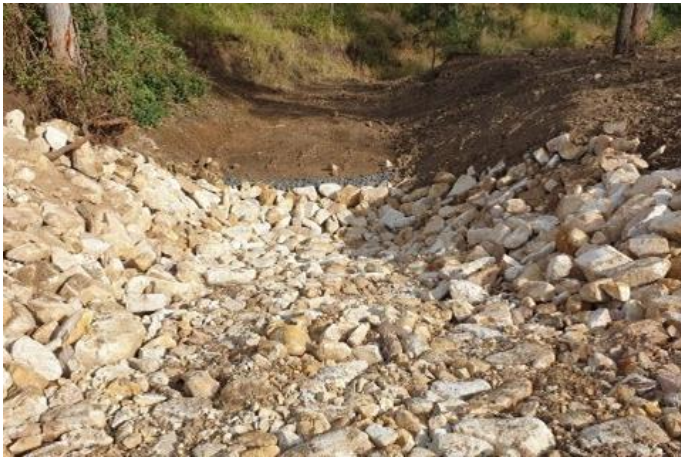
Figure 6. The rock chute after track rolling (looking downstream).

- **Reprofile the head cut and gully sides** with a 1:4 slope where possible.
- **Create trenching** to secure the geofabric at the top of the chute.
- **Overlay geofabric** across the entire chute and trenching.
- **Lay sandstone rock and track roll** down to create a compacted, interlocking surface.
- **Construct contours** 1.2 m high with topsoil separated and spread over the top of the contour.
- **Revegetate the batter and contours** with grass cover across all exposed soil.
- **Install vetiver hedges** across the channel to slow incoming flow.

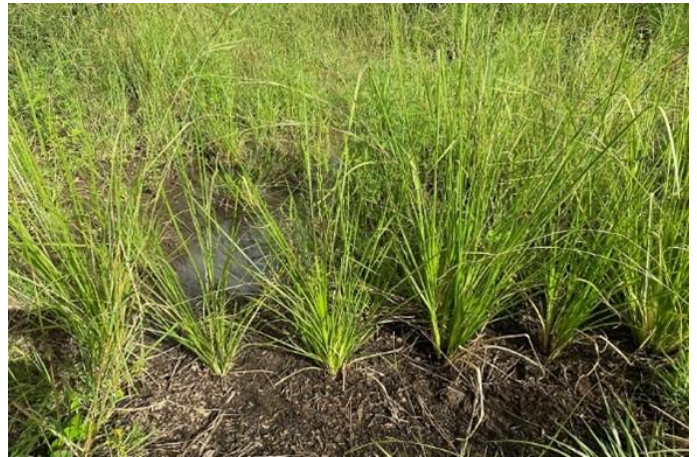
Figure 7. Vetiver hedges were installed to slow and redirect the flow of runoff entering the chute.

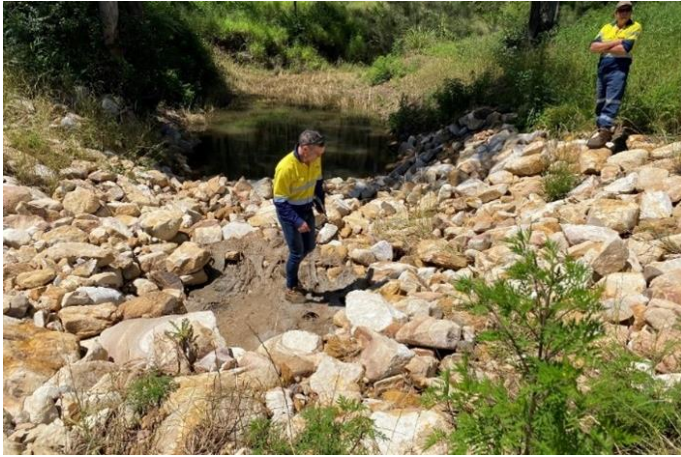
A few months after installation, a significant rain event occurred which caused damage to the chute. The rock moved through the centre of the chute creating a bare patch which compromised the integrity of the structure and would continue to erode under subsequent rainfall events. To reduce the risk of further damage, the dislodged rocks were moved back into position and concrete was placed over the chute, ensuring good penetration and integration with the rocks. This has worked successfully in three flood events that followed holding the rock in place and protecting the old gully head cut from advancing into the paddock.

**Figure 8.** Some of the rock had been displaced during a rainfall event exposing the underlying damaged geofabric and soil.

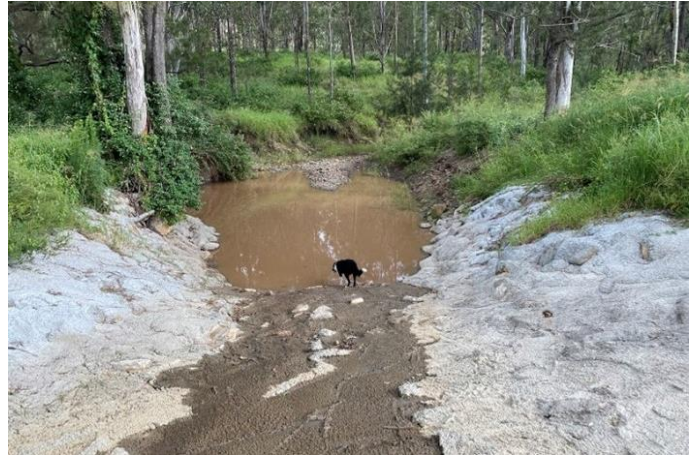
**Figure 9.** Concrete was used to secure the rock and stabilise the chute.
