Gully erosion repair

Case study: Gully erosion repair – Using a concrete mat

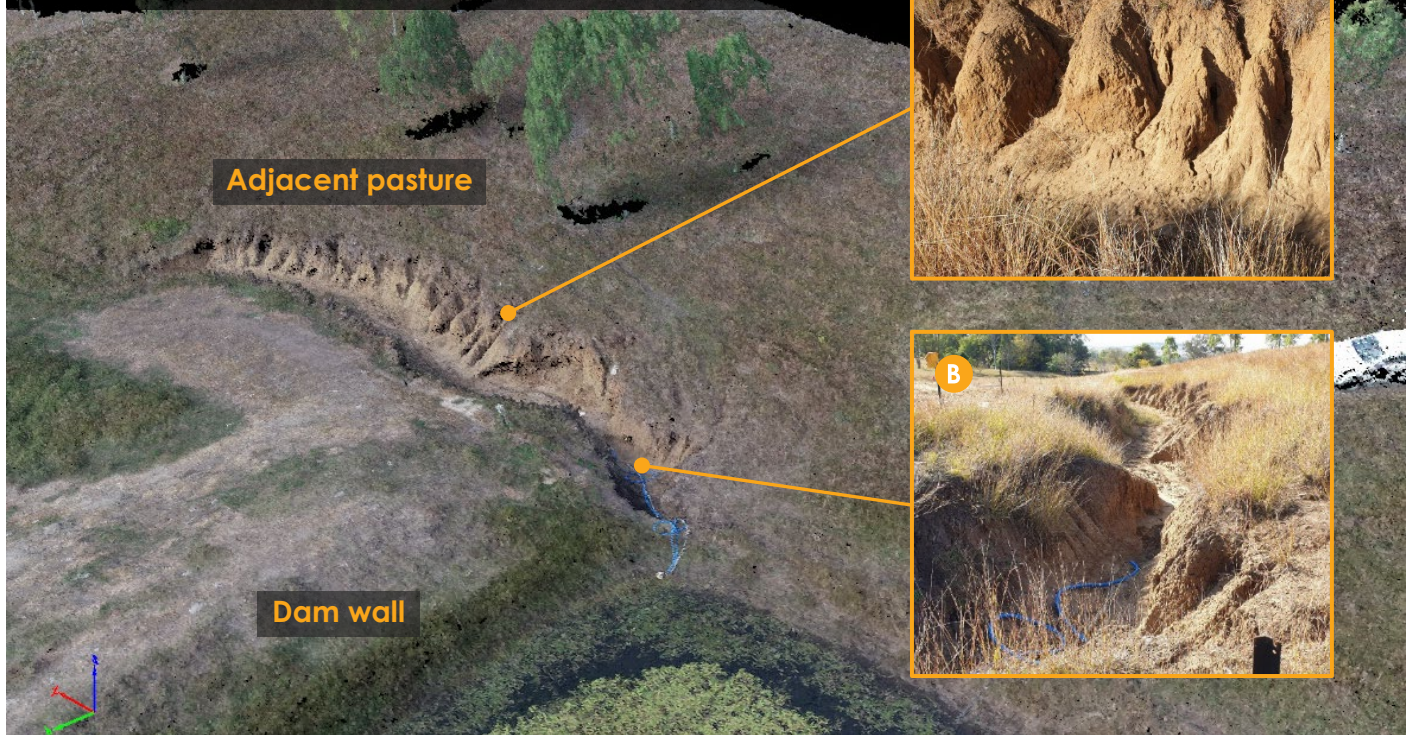
Gully erosion was affecting the overflow area of a small farm dam on a grazing property near Rosevale in South East Queensland. The gully had cut into the dam wall and without intervention would soon cause the dam to fail. The area had been used as a cattle pad, which in combination of fast-flowing water from a nearby poorly designed spillway, wore away the thin topsoil and exposed the sodic subsoil.

Sodic soil disperses or 'melts' very quickly when it gets wet, meaning that once the few centimetres of topsoil are gone, gully erosion can quickly take hold. About 360 tonnes of soil has been lost from this gully over the last ten years, which is 36 tonnes per year. Runoff from the adjacent pasture was causing further damage (Inset A).

Figure 2. Aerial view of the erosion site before the erosion control work began. Inset A shows where runoff from the adjacent pasture was causing further damage. Inset B shows where the gully erosion continued from the dam wall down into the paddock.

After careful planning and design, a cement mat chute supported by rock edging and stilling well (apron) was installed.

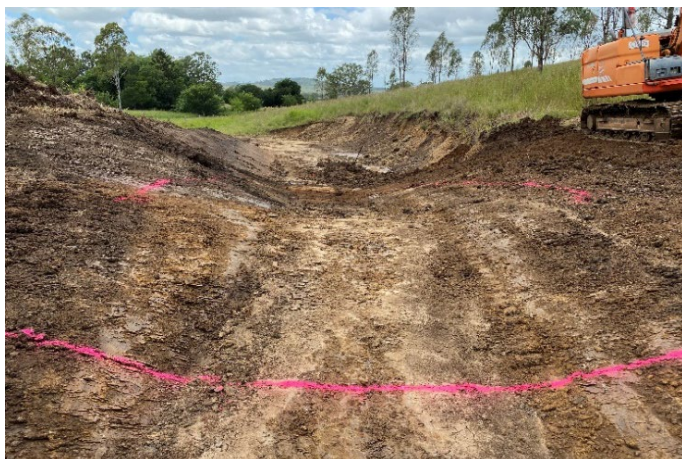
Figure 6. The gully sides were reprofiled to a 1:4 batter.

- **Batter gully sides** and remove the bank confining flows.
- **Reprofile the head cut and gully sides** using clay fill (from dam) and subsoil from reshaping the gully to create a 1:4 batter.

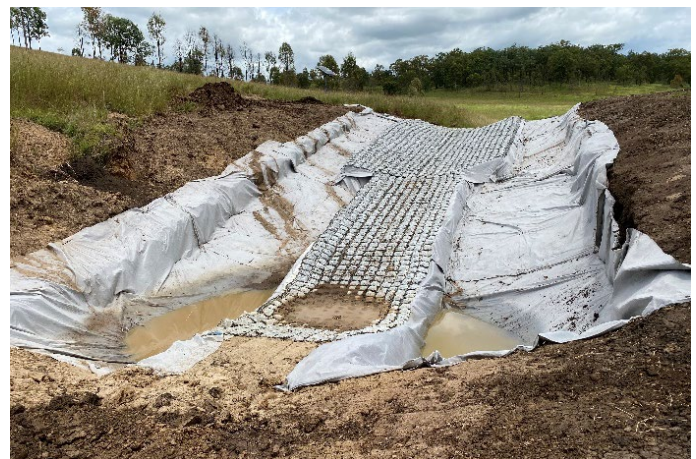
Figure 7. Geofabric overlayed across the entire chute and trenching and cement matting overlayed across the chute.

- **Overlay geofabric** across the entire chute and trenching.
- **Overlay cement mats** ensuring a minimum of two rows of cement blocks over the sides.

- The concrete matting came with its own geofabric lining which was too thin and broke down during a big rain event. This caused some erosion to occur underneath the matting. A44 bidum is the recommended minimum specification geofabric needed to protect the integrity of the chute and underlying soil.
- Don't step down from a two mat width to a one mat design. The excavation and boxing was more time consuming and expensive and did not deliver additional benefits.

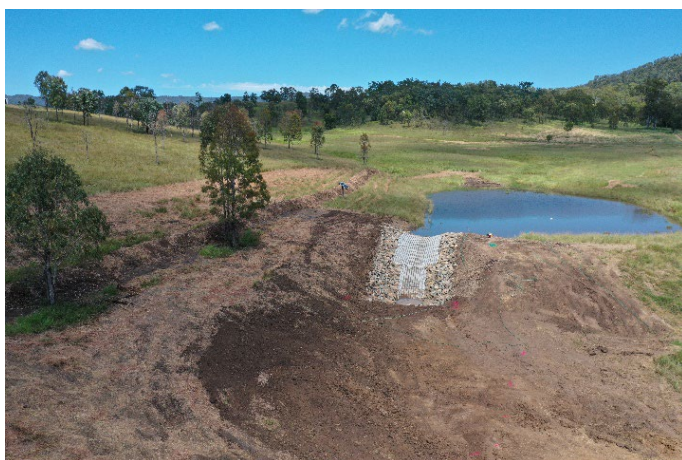
Figure 8. After construction the bare areas were seeded with a mix of productive perennial grasses and a cover crop.

- **Place rocks into trenches** surrounding the cement chute, ensuring that rock entry is flush with ground at the top of the chute.
- **Revegetate the batter** with grass cover across all exposed soil and plant vetiver hedges at the base of the chute.

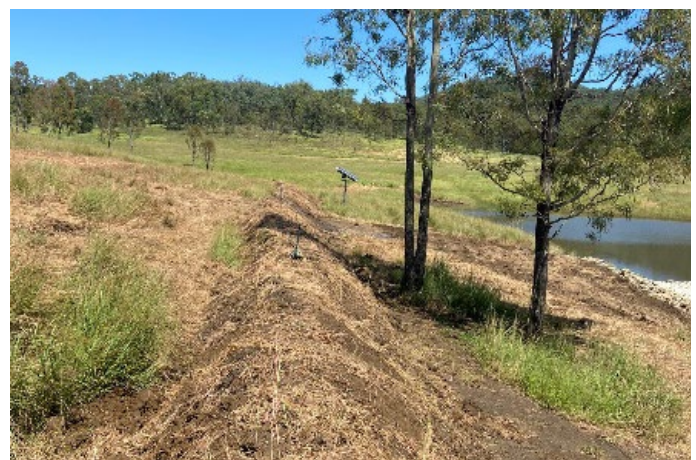
Figure 9. A contour bank was installed to divert runoff away from the restoration site.

Contour bank construction an essential design features:

- 1:10 fall ensuring topsoil is separated and put back on top.
- Compacted every 400 mm.
- Push up the hill from below contour.
- Ending the contour directing the water to a wide open, flat area above the dam.
- Seed the contour and the exposed soil below it to establish groundcover.
- Vetiver hedges installed where water is entering the gully above dam to slow velocity of runoff to prevent future erosion.
