State of South-east Queensland Waterways Report 2001

Editors:
Eva Abal,
Kate Moore,
Badin Gibbes and
Bill Dennison

Moreton Bay Waterways and Catchments Partnership, 2001

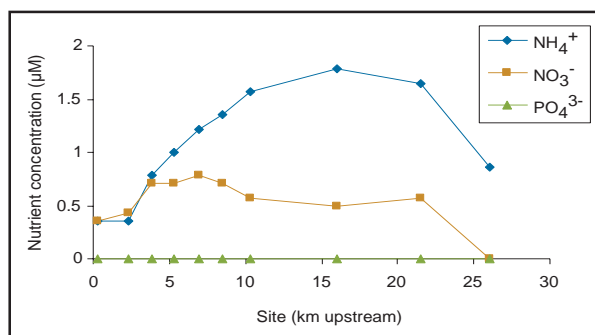
Figure 2.4: Dissolved water column inorganic nutrients in the Noosa River under base flow conditions

Dissolved inorganic nutrient concentrations in the Noosa River (Fig 2.4) are one to two orders of magnitude lower than those in many other south-east Queensland rivers. Inorganic nutrients make up a small fraction of the total nutrient concentration in the Noosa River, indicating that particulate and/or dissolved organic nutrients are the major nutrient form (Fig 2.5). Given the relatively low turbidity in the Noosa River, it is more likely that dissolved organic nutrients dominate the system (Table 2.2). These nutrient characteristics of the Noosa system are consistent with those of a healthy, natural waterway.

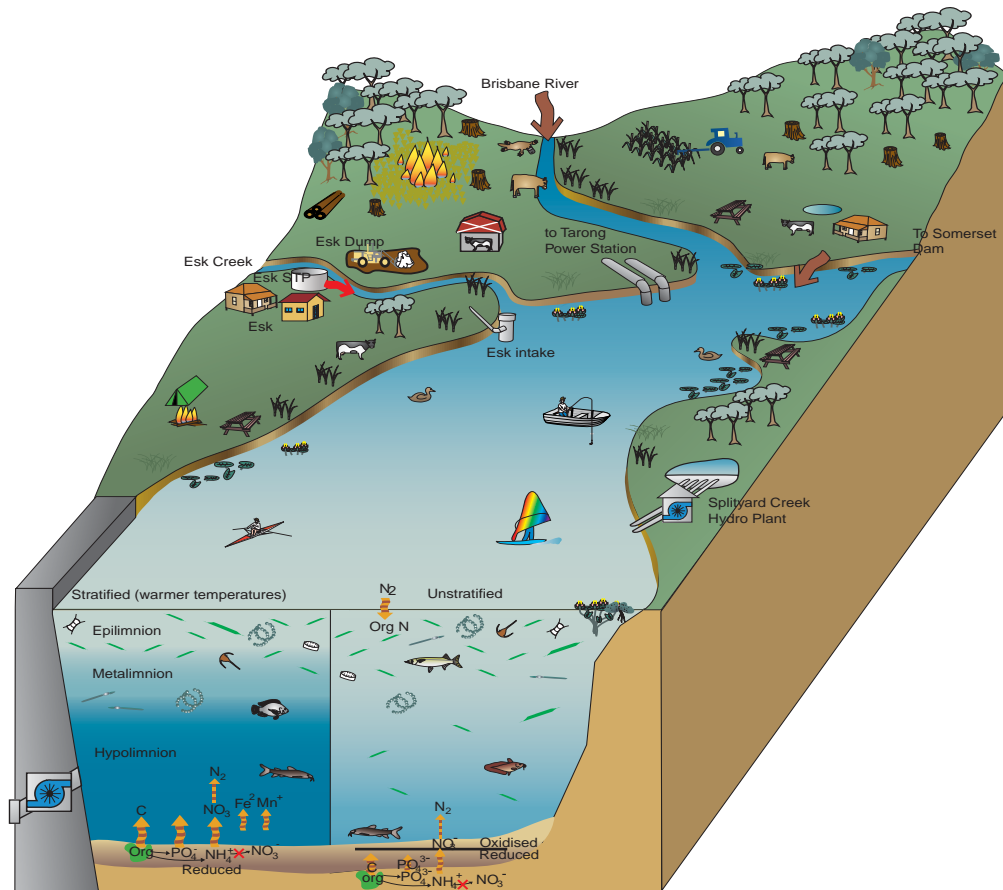
Conceptual model for Wivenhoe Dam
