# Salinity in the Lockyer Valley

## Identifying salinity

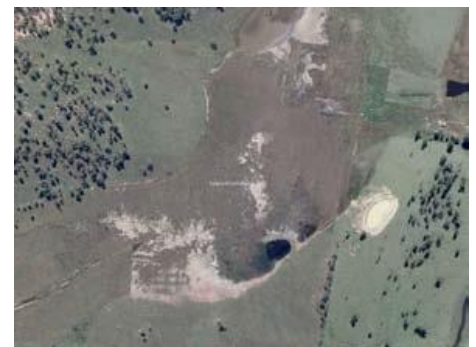
**Image 1:** Dams can have an impact on the water balance and result in rising water tables, concentration of salts and in severe cases bare ground which are more susceptible to erosion.

Natural and man-made features in the landscape that affect the incidence of salinity include placement of dams (Image 1), drainage characteristics of the catchments including where streams meet, and changes in geology or topography (Figure 1).

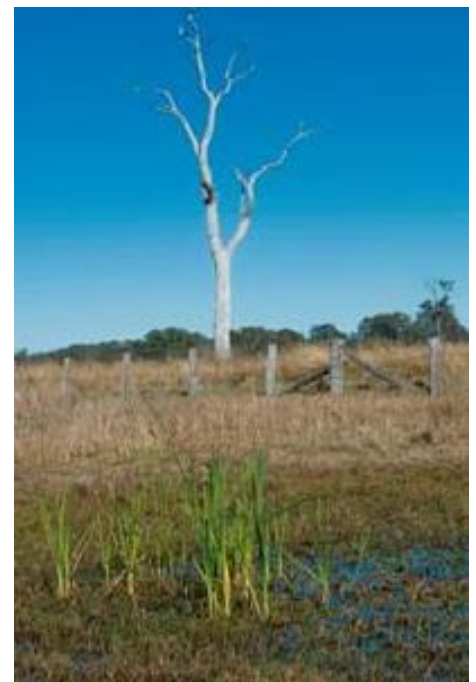
**Image 2:** Waterlogged areas (foreground) and tree dieback (background) may be indicators of saline areas.

- Waterlogged (Image 2) or remains wet for extended periods.
- Bare or has a poor vegetation cover.
- Growing salt tolerant plant species such as marine couch, salt bush or black tea-tree.
- Showing signs of vegetation dieback.
- Suffering from poor yields
